**MECHANICAL TEST IN-SITU FRACTURE DEVICE FOR
AUGER ELECTRON SPECTROSCOPY**

R. Dale Moorhead

**Ames Research Center
Moffett Field, Calif. 94035**

September 1975

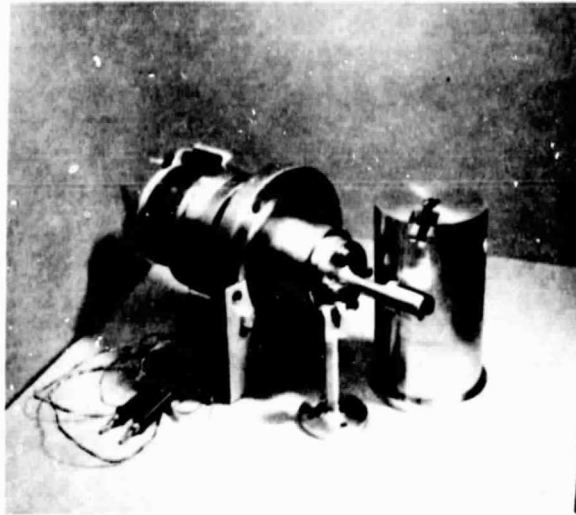
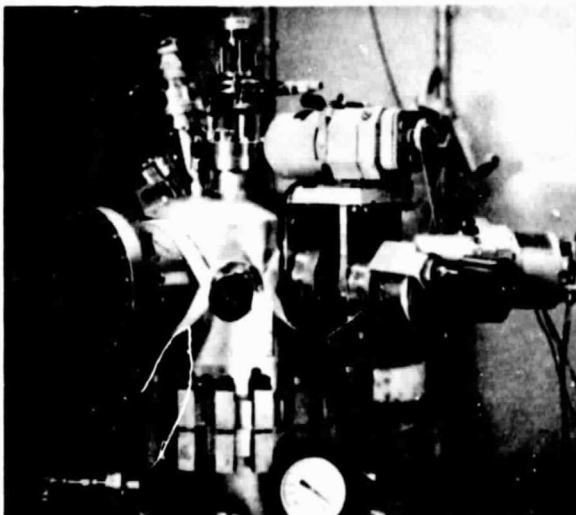
Figure 1.— (a) Fracture device partially disassembled. The large cylinder is the load frame. The extra (unattached) clevis with the pin is used for the DCB type of specimen. (b) Fully assembled with a DCB specimen in the loaded position. (c) General view of Auger spectrometer with fracture attachment installed.

This finally took the shape of a cylinder which is seen detached and sitting upright in Fig. 1(a). The cylinder is machined from high-grade steel and is bored to a size just large enough to permit it to slip over the bellows sleeve of the vacuum assembly and come to rest against the inside surface of the vacuum flange, as shown in Fig. 1(b). Slots and openings machined into the closed end of the cylinder at various locations and directions are for loading and alignment of the specimen. The specimen is gripped by dowel pins pressed into holes in the specimen ends. Figure 2 is a cutaway view of the apparatus as it appears with a tensile specimen in the loaded position. The free end of the specimen is fed into the apparatus through the horizontal and vertical slots in the bottom half of the load-frame cylinder and springs up to be caught by the yoke attached to the bellows and screw. For DCB specimens, the yoke shown attached in Figs. 1(a) and 2 is replaced by a clevis type with a fixed pin shown unattached in Fig. 1(a). The DCB specimen is manipulated into the assembly in such a way that the "hook" side of the specimen is caught by the clevis pin. A DCB is shown in the loaded position in Fig. 1(b).
